Restoring the base of a national landmark in Azerbaijan

STATE FLAG SQUARE, AZERBAIJAN

Steve Davies of **Beton Bauen** reports on a demanding overseas project – involving environmental extremes, international logistics and a tight schedule – to repair the concrete base of a national landmark in Azerbaijan.

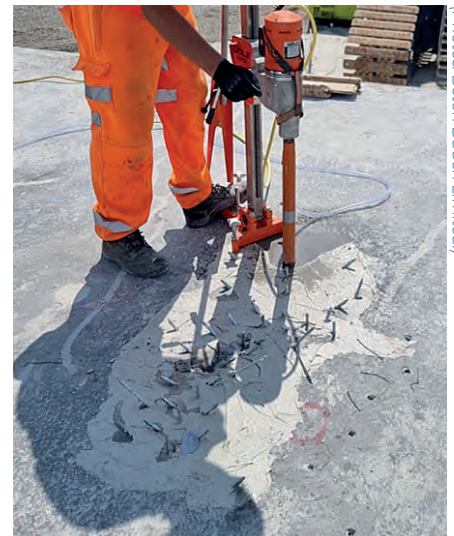
BELOW TOP RIGHT:

Testing. Coring of the repair area (slab) to test if the resin injection process is successful.

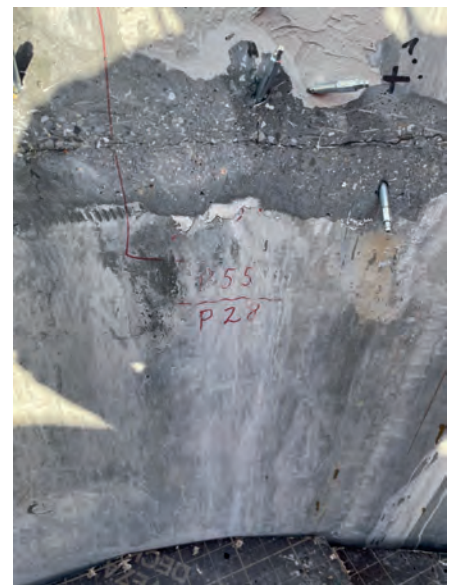
ABOVE RIGHT:

Installed packers, prior to resin injection (to inner core wall).

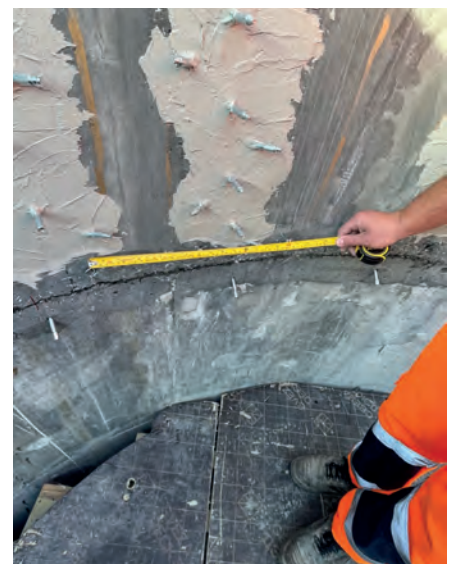
RIGHT:

Surface sealer (Sikadur), applied near packers (to inner core wall).

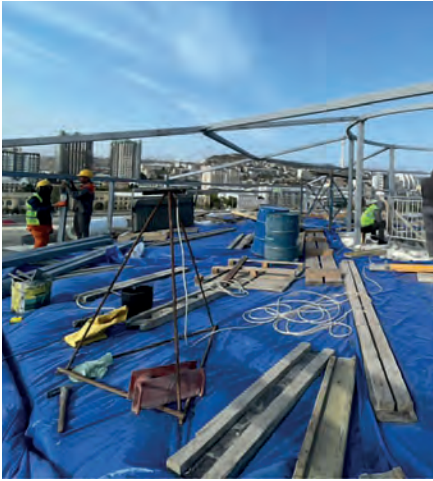
TOP LEFT:

Setup for protection from elements.

High winds on the shoreline of the Caspian Sea threatened to undermine the specialist grout and resins. Applied materials needed to be given protection from the wind (yet kept moist) to gain in strength and prevent premature curing. To combat these issues, temporary working shelters were constructed.

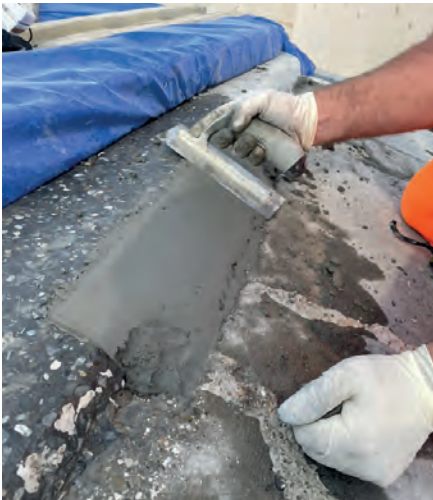
MIDDLE:

Concrete infill.

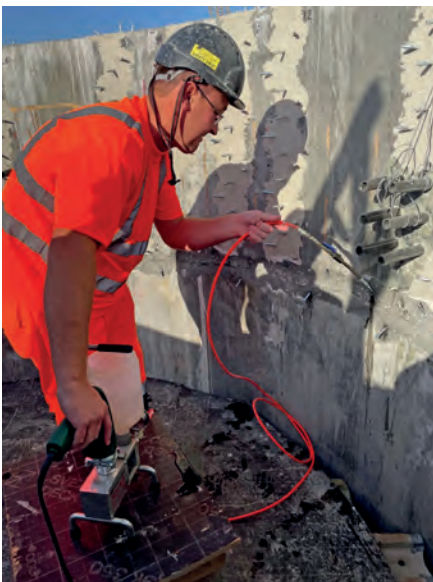
BOTTOM:

Resin injection application process.
